**DEPARTMENT OF TRANSPORTATION**

Contract #: 04-0120F4Cty: SF/ALA Rte: 80 PM: 13.2/13.9File #: 69.28**WELDING INSPECTION REPORT****Resident Engineer:** Pursell, Gary**Address:** 333 Burma Road**City:** Oakland, CA 94607**Report No:** WIR-004464**Date Inspected:** 02-Nov-2008**Project Name:** SAS Superstructure**OSM Arrival Time:** 1430**Prime Contractor:** American Bridge/Fluor Enterprises, a JV**OSM Departure Time:** 2230**Contractor:** Zhenhua Port Machinery Company, Ltd (ZPMC), Changxing Island **Location:** Shanghai, China**CWI Name:** Sun Bo**CWI Present:** Yes No**Inspected CWI report:** Yes No N/A**Rod Oven in Use:** Yes No N/A**Electrode to specification:** Yes No N/A**Weld Procedures Followed:** Yes No N/A**Qualified Welders:** Yes No N/A**Verified Joint Fit-up:** Yes No N/A**Approved Drawings:** Yes No N/A**Approved WPS:** Yes No N/A**Delayed / Cancelled:** Yes No N/A**Bridge No:** 34-0006**Component:** OBG**Summary of Items Observed:**

Caltrans Quality Assurance (QA) Inspector, Larry Viars was present to perform Ultrasonic Testing (UT) of Orthotropic Box Girder (OBG) components, for the San Francisco Oakland Bay Self Anchored Suspension Bridge, at Zhenhua Port Machiner

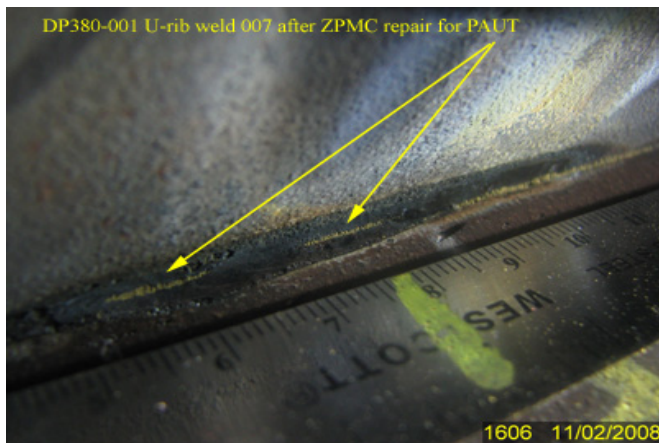
Caltrans QA performed visual inspection of Deck Panel DP380-001 weld 007 repair area (Y location 75) previously rejected with phased array and visual inspection for horizontal cracks on the root pass open to the surface. Cracks were first observed on 10/30/08 during phased array testing and found noncompliant with phased array ultrasonic testing. Visual inspection was performed of the area and two horizontal cracks with a combined length of approximately 20 mm were found and verified with Magnetic particle testing. Cracks were shown to ZPMC QC Sun Bo, Wang Lu and Kelvin Cheung. Caltrans QA observed that repair had been made but the crack on the root was not removed. ZPMC QC Lei Tao stated that repair performed only requires the weld to be excavated to a depth of 9.6 mm from the weld and that ZPMC considered this repair complete. An incident report was issued for ZPMC knowingly violating the following applicable references AWS D1.5 (2002) section 6.26.2 which states "Welds that are subject to RT or MT in addition to visual inspection shall have no cracks and shall be unacceptable if the RT or MT shows any types of discontinuities described in 6.26.2.1, 6.26.2.2, 6.26.2.3, or 6.26.2.4", AWS D1.5 (2002) section 3.7.2.4 which states "Cracks in the weld or base metal, the extent of the crack shall be ascertained by the Use of MT, PT or other equally positive means; the metal shall be removed for the full extent of the crack plus 50 mm beyond each end of the crack." ZPMC repair procedure for closed ribs section 2.5.2 which states "Carefully remove crack by grinding in accordance with AWS D1.5 Section 3.7.2.4. Please see the

photo below which shows the above mentioned crack after ZPMC weld repair.
